Using Automated UT at San Francisco's New Airport Terminal

Using automated ultrasonic testing in a one-of-a-kind situation proves beneficial

BY EDWARD KING

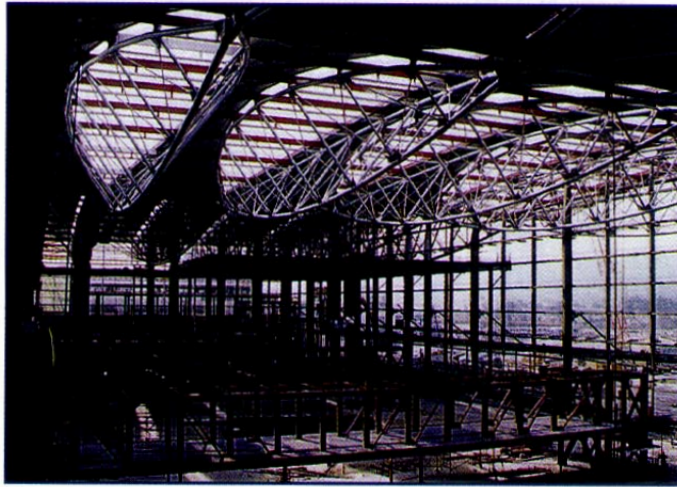
Fig. 1 — The football-shaped trusses at San Francisco International Airport.

Imagine arriving for your first visit to the United States at the new San Francisco International Airport (SFIA). You step into the new international terminal with its 83-ft-high ceilings and skylights held aloft by giant football-shaped trusses spanning 840 ft in overall length — Fig. 1. The west window wall alone is 700 ft long and more than 80 ft tall. The effect of natural light from the combination of the huge window wall and roof skylights is totally stunning. You find yourself completely mesmerized, taking in the power and grace of the roof structure 80 to 90 ft above. Is this an airport or a cathedral?

The new international terminal's roof structure is to be supported by large-diameter (12–14 in.), heavy-walled (2.5-in.-thick) pipe trusses that support a clear span roof structure of more than 800 ft, approximately 80–90 ft above the new main terminal entrance. The trusses have about 140 critical field splices to be performed on scaffolding directly above the existing eight-lane thoroughfare into the airport terminal.
